# GEOTECHNICAL REMEDIATION STRATEGIES FOR THE ANCIENT MONASTERY OF DANGKHAR

INSTITUTE OF APPLIED GEOSCIENCES - GRAZ UNIVERSITY OF TECHNOLOGY

D.S. Kieffer and C. Steinbauer  
January, 2012

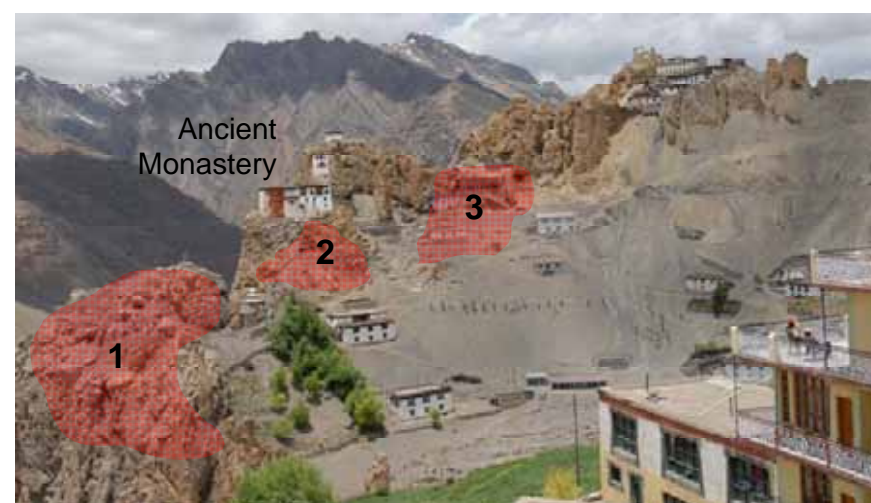
Figure 1.4. Condition of the existing Ancient Monastery, showing approximate areas of prior significant structures as indicated by historical portrayals.

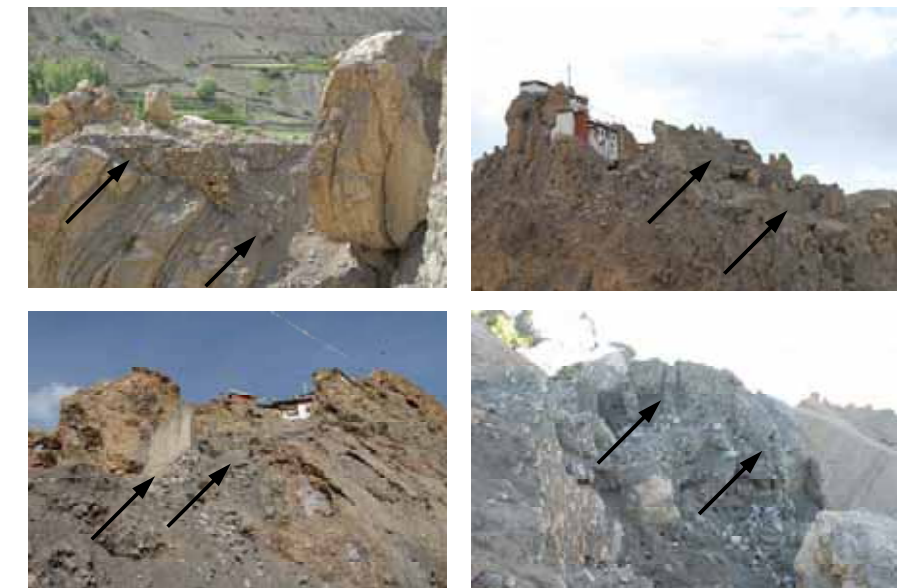
Figure 1.5 Foundation remnants within Areas 1 and 2 of Figure 1.4 (arrows point to the foundation - earth interface).

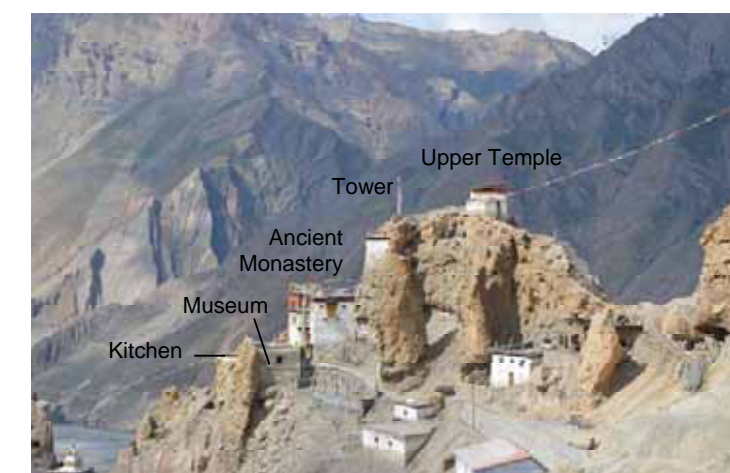
Figure 2.8 Structures of the Ancient Monastery Complex.

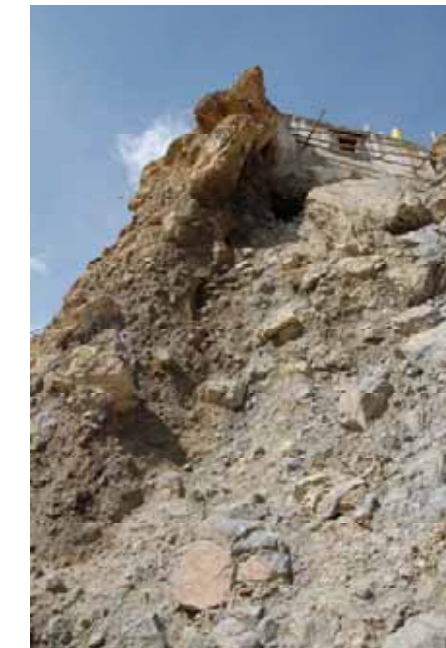
Rocks comprising the bold cliffs of Dangkhar are characterized by a heterogeneous and chaotic mixture of angular rock blocks in a fine grained matrix (Fig 2.10). The rock blocks consist primarily of angular to subangular limestone, and range in size from cobbles to over 10 cubic meters in volume. The volumetric proportion of blocks is estimated to typically range from about 30 to more than 50 percent, with blocks tending to be matrix supported. While the origin of these deposits can be debated, it is their engineering behavior that is particularly germane to this study.

Medley (1994) proposed the term *block-in-matrix rocks* (or *bimrocks*) to classify a range of geologic deposits having the overall characteristics of those comprising the cliffs of Dangkhar, and this terminology has been adopted in this study. The engineering properties of bimrocks depend on the volumetric block proportion of the deposit, together with shear strength and stiffness properties of the block and matrix components (Medley, 1994; Lindquist, 1994). While the blocks at Dangkhar exhibit higher strength characteristics than the matrix components, both tend to be strong to very strong (Grades R4 to R5 according to Brown, 1981), with uniaxial compressive strengths for unweathered specimens estimated in the range of 50 to 250 MPa.

Figure 2.10 Typical characteristics of the bimrock materials forming the cliffs of Dangkhar.

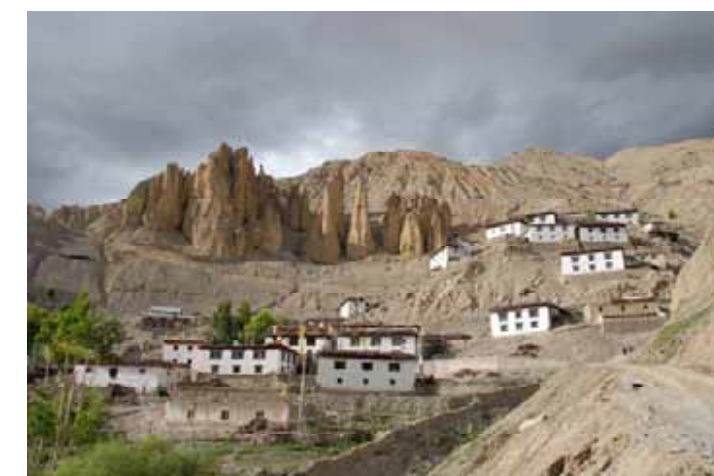
The bimrock exposures at Dangkhar are surrounded in their entirety by unconsolidated surficial sediments (Fig 2.11). The sediments range predominately from silt to boulder size, and are interpreted to represent processes of colluviation (diffusive downslope movement of surficial sediments through the action of gravity and water), rockfall accumulation, and in-situ decomposition of parent materials. The overall term *talus* is used to describe these sediments. The distribution of bimrock and talus materials in the vicinity of the Ancient Monastery Complex is shown schematically in Figure 2.9.

Figure 2.11 Bimrock outcrops in Dangkhar Village, surrounded by unconsolidated surficial sediments.

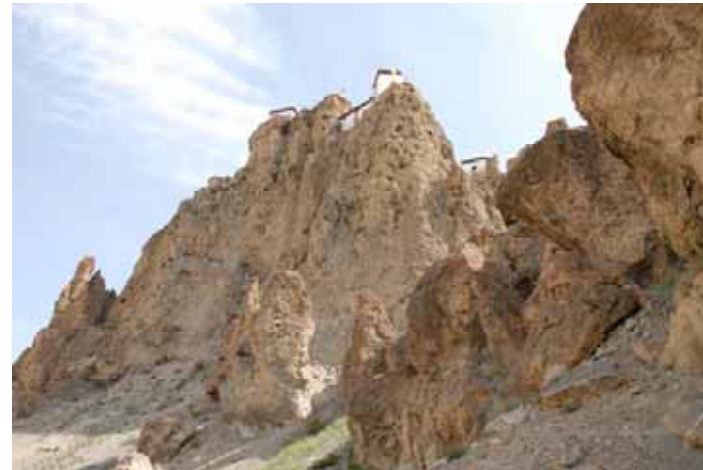
Outcrops of the bimrock at Dangkhar are typically near-vertical, reaching heights of approximately 65 m directly adjacent to foundations of the Ancient Monastery Complex (Fig. 2.12).

Figure 2.12 Bimrock foundation of the Ancient Monastery Complex.

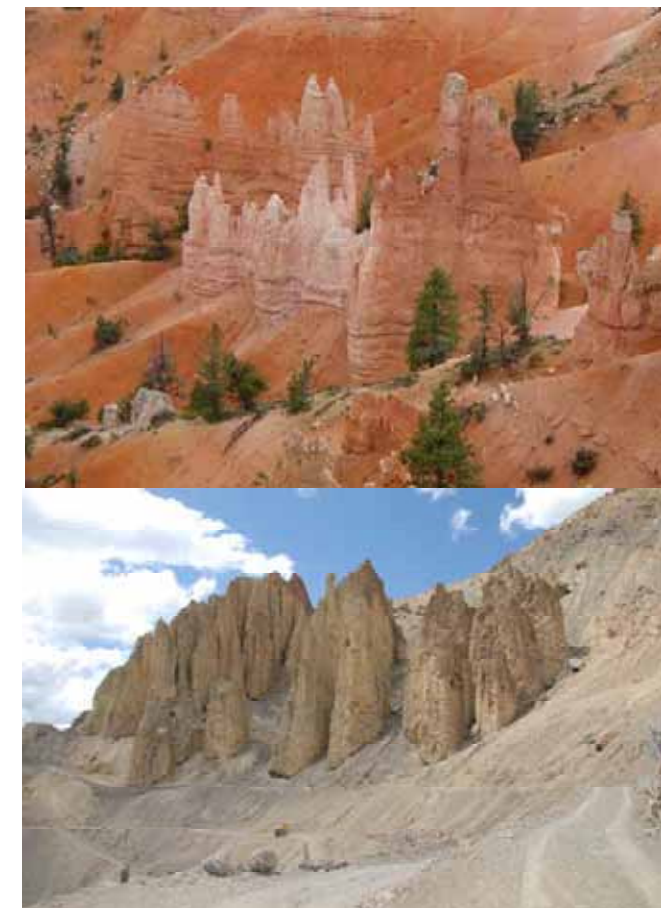
Morphologically, the landscape at Dangkhar exhibits a *badlands* character, which is commonly associated with arid environments having little vegetation and variably cemented sedimentary formations, sometimes containing soluble minerals. Figure 3.1 shows the similarity between classical badlands features of Bryce Canyon in the southwestern United States, to features observed at Dangkhar. Badlands landscapes are formed by the action of surface waters and are typified by short steep slopes with narrow interfluves.

Figure 3.1 Badlands features of Bryce Canyon (above) and Dangkhar (below).

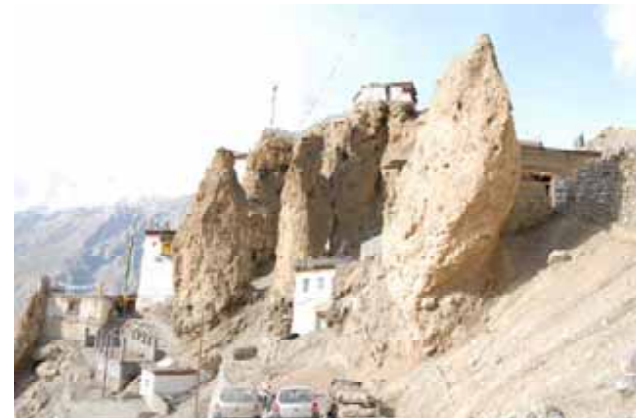
A typical feature of badlands landscapes are *hoodoos* (earth pillars), several of which are depicted in Figure 3.2. Hoodoos represent the last vestiges of a landscape progressively eroded by water, and with their eventual destruction, the landscape assumes a lower overall elevation. Hoodoos sometimes are overlain by a resistant *cap rock* (Fig. 3.3), which serves to protect the pillar from the erosive capacity of rainfall, thereby enhancing the pillar's longevity.

Figure 3.2 Hoodoos (earth pillars) located directly north of Ancient Monastery Complex.

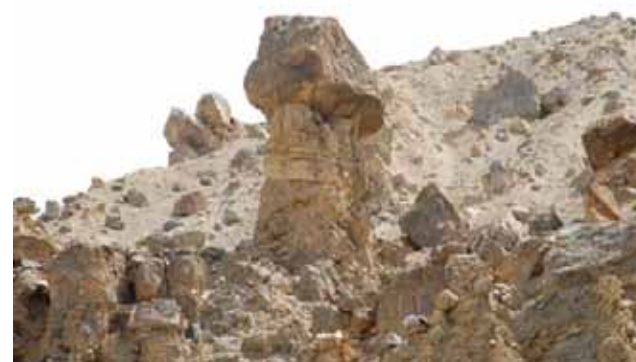
Figure 3.3 Resistant cap rock protecting a hoodoo.

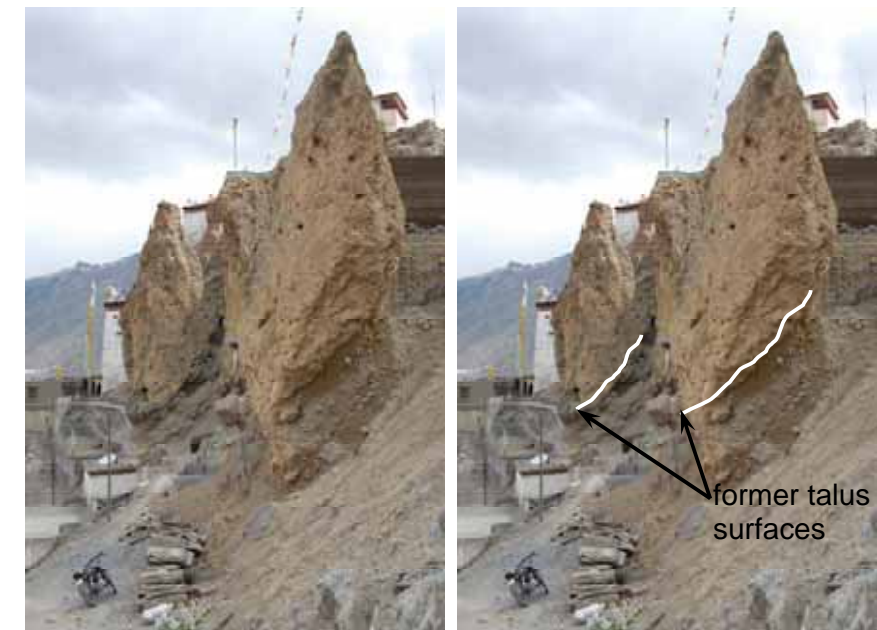
Commonly, the hoodoos of Dangkhar exhibit a tapered shape, narrowing toward the base (Fig 3.4). The narrowing is interpreted to result from the erosive action of surface rill and sheet flow, which interacted with the pillar in a former time, when the bordering talus deposits occupied a higher elevation. The surface waters would have been directed down the talus surface to the pillar boundary, where direct exposure to flowing water would result. An example of pillar tapering occurring along the boundary of an existing talus surface is depicted in Figure 3.5. The former talus deposits in the case of Figure 3.4 may have been removed by natural erosion or human activity.

Figure 3.4 Common tapered form of the Dangkhar hoodoos, showing narrowing at the base rock protecting a hoodoo. Left image indicates position of interpreted former talus surface.

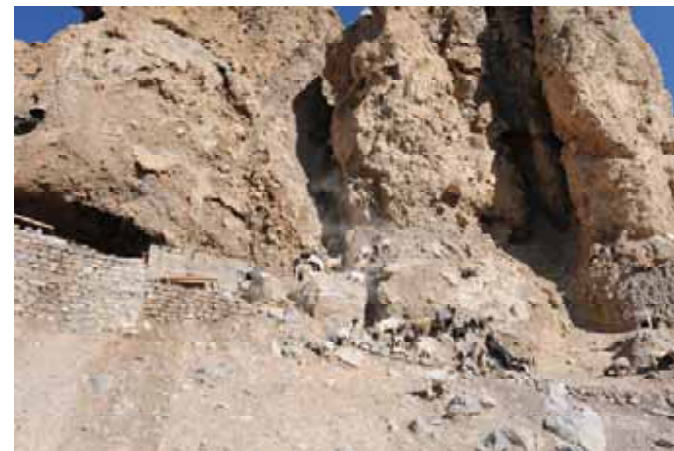
Figure 3.6 Goats accessing hoodoo base (note dust cloud indicating erosion).

Exacerbating the pillar tapering is the activity of livestock. As shown in Figures 3.6, goat herds gain access to the base of the hoodoos, where their action results in minor progressive narrowing of the hoodoo base. Not only does erosion result from hoof action, but also the nibbling of bits of rock (Fig 3.7). The mineralogical content of the pillar material, based on a single X-ray diffraction analysis, is approximately 80% calcite, 10% dolomite; and 10% quartz, suggesting the goats may derive from these materials a calcium-magnesium nutritional benefit.

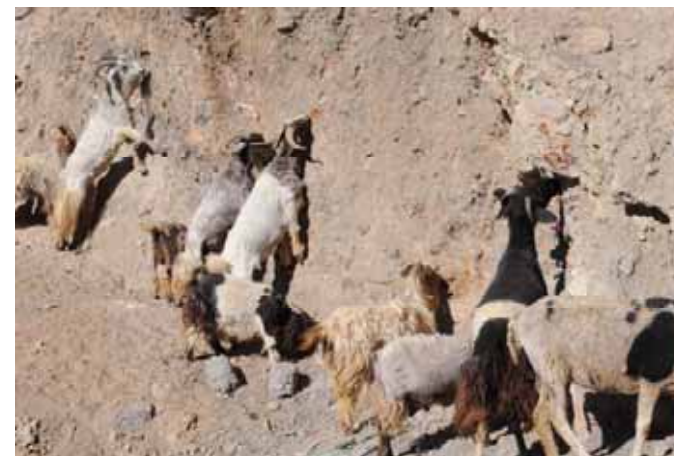
Figure 3.7 Goats nibbling on base of hoodoo.

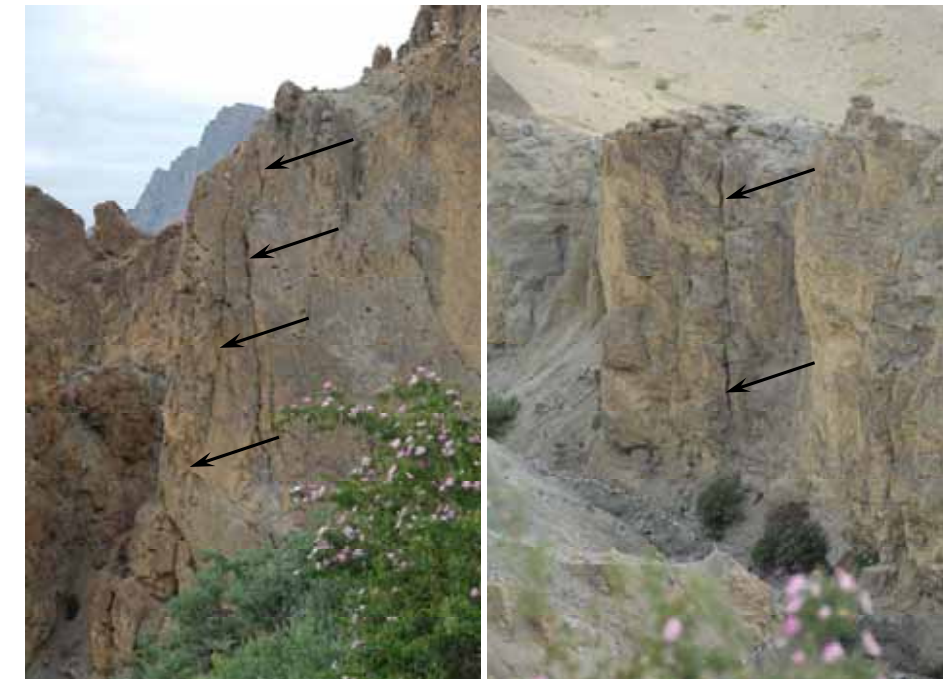
Figure 3.8 Tensile fracturing of the Dangkhar Bimrock.

As erosion progresses, the more resistant bimrock materials tend to take on bolder forms, increasing their height and steepness. Their exposure is accompanied by stress relief, which manifests itself as tensile cracking of the bimrock. Figures 3.8 and 3.9 show typical examples of the stress relief fractures, which tend to dip very steeply to vertical, and strike subparallel to the free surface.

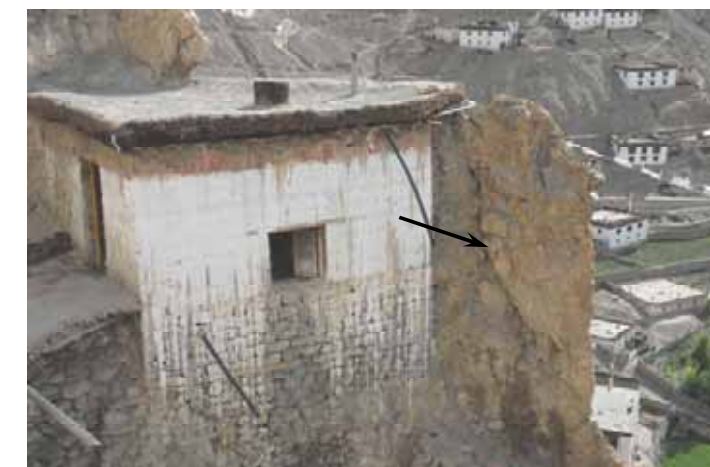
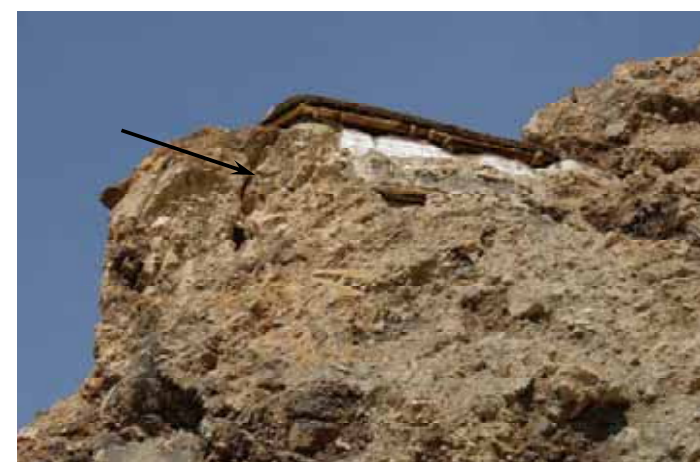
Figure 3.9 Tensile fracturing adjacent to monastery structures.

Once formed, the tensile fractures act as potential detachment surfaces for toppling and rockfall-type events. The fracture surfaces are also exposed to water, which tends to slowly erode particles from the exposed surfaces, gradually enlarging the fracture aperture. Eventually, erosion rills develop, which tend to enlarge to eventually form isolated hoodoos (Fig 3.10). Also shown in Figure 3.10 are pits and vugs. Together with the localized occurrence of small caves, these features indicate calcium carbonate dissolution as a component of the erosion process.

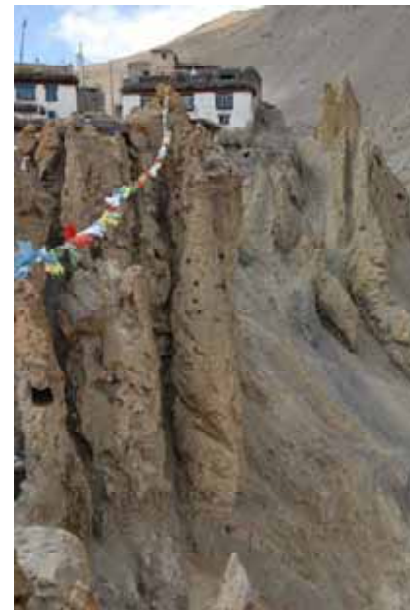
Figure 3.10 Development of erosion rills at the site of tension cracks, leading to hoodoo formation.

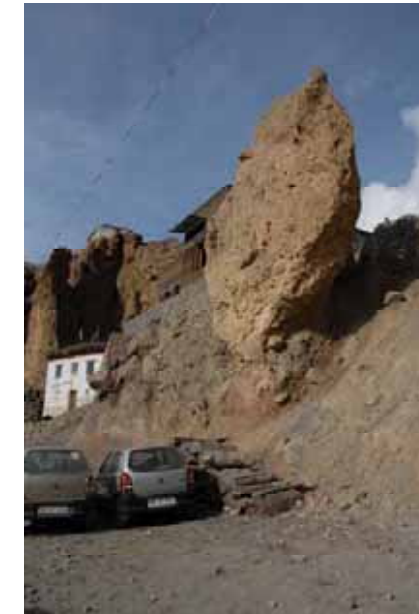
Isolated hoodoos (Fig 3.11) are subject to continued diffusive particle erosion and dissolution, which may eventually bring the pillar to a critical state of eccentricity, making it prone to toppling (particularly under the action of seismic shaking). In the bimrock erosion process, fine grained components tend to be preferentially eroded through freeze-thaw loosening, wind abrasion, and surface water interaction. Retreat of the finer grained matrix around large block components (Figure 3.12) tends to undermine or loosen the blocks, and precipitate discrete rockfall events.

Figure 3.11 A precarious isolated hoodoo.

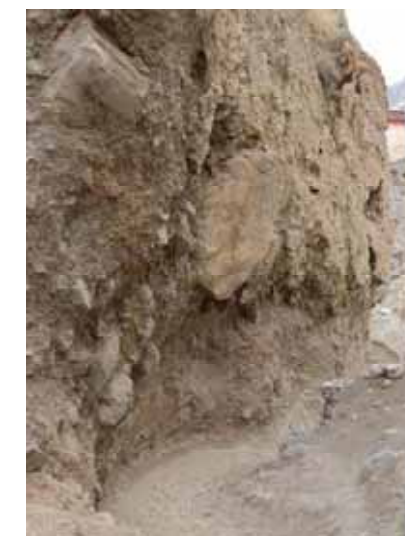
Figure 3.12 Differential erosion of block and matrix components, leading to the undermining and loosening of large block components

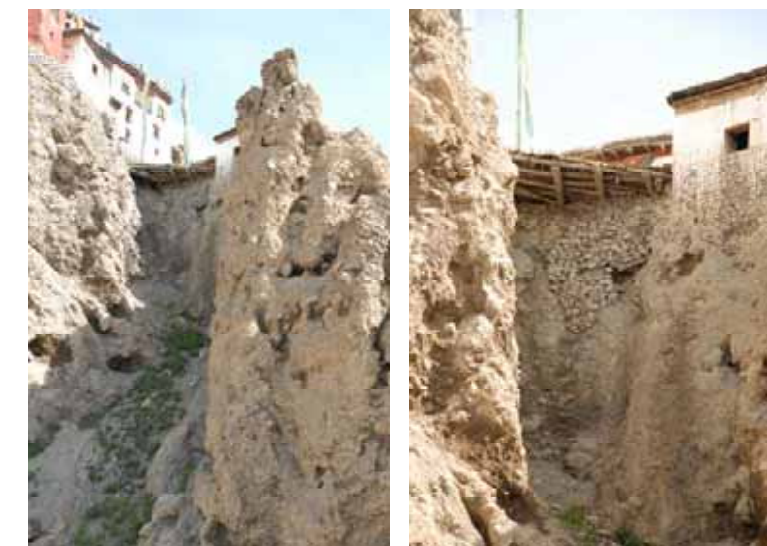
Figure 3.15 Erosion gully along eastern side of Ancient Monastery and southern side of Kitchen (note partial undermining of block-mortar work in the erosion headwall).

The bimrock cliffs bordering the southern side of the Ancient Monastery are near vertical and range in height from about 10 to 40 m (Fig 3.14). A substantial erosion gully occurs along the eastern side of the Ancient monastery (and along the southern side of the Kitchen). As depicted on the geologic map (Fig. 2.9) and in Figure 3.14, the gully contains loose surficial sediments (talus) in its throat, deposited through the process of cliff erosion and retreat. The cliff retreat has apparently advanced to the stage of requiring mitigating construction, including a cantilevered patio, and block masonry support work in the upper portion of the erosion headwall. Figure 3.14 reveals partial undermining of the block masonry support work, and Figure 3.15 shows four water drainage pipes, discharging over the cliff and directly into the erosion gully.

The erosion gully developed along the eastern side of the Ancient Monastery (and southern side of the Kitchen) shows signs of active erosion. The gully has a high potential for continuing retreat, and the risk to foundation elements supporting the Ancient Monastery and Kitchen is considered significant.

As enumerated below, diversion and control of surface runoff is imperative to attenuate the erosion process, however, drainage improvements alone are considered insufficient for mitigating the risk of structural undermining. To address this risk, it is recommended that surface protection be provided for the steep side slopes of the gully. Options considered for surface protection include block/mortar walls, chemical membranes (e.g. polyurethane), and a sprayed concrete (shotcrete) membrane. The first option was rendered impractical due to the significant height of the walls, and the lack of firm bearing material in the throat of the gully (which is filled with loose talus). The second option could be implemented, however, the durability of chemical membranes under harsh climatic conditions such as Dangkhar remain unproven. For this reason, the option of a shotcrete membrane was considered most suitable.

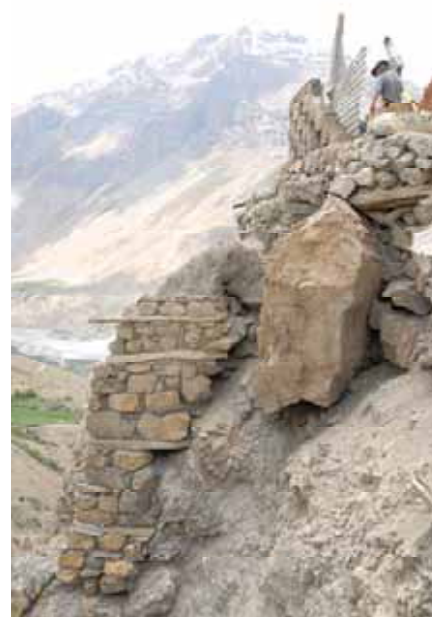
Figure 3.17 Partially undermined large block along eastern side of Ancient Monastery.

Figure 3.17 shows as a large block that has essentially been isolated by the differential bimrock erosion process (i.e. preferential erosion of fine grained matrix components). The block is situated less than two meters from the eastern monastery wall, and provides support for a small walkway and low protection wall. The large block has been partially undermined, and its lateral extent beneath the walkway is unknown.

As described in Section 3.2.1, a partially undermined block is situated less than two meters from the eastern monastery wall, and provides support for a small walkway and low protection wall. It is recommended that the block be underpinned by constructing a small block/mortar mass below its toe. Due to the steepness of the underlying surface, a horizontal notch will need to be carefully excavated to form an adequate bearing surface for the block/mortar underpin. An alternative method for supporting the block is to fill the undermined area with shotcrete.

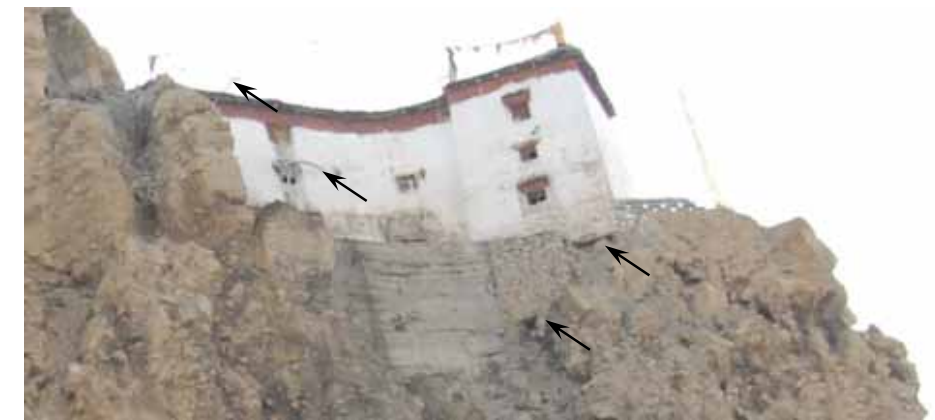
Figure 3.18 Southern side of Ancient Monastery, showing area of prior remedial cliff work (note two drainage pipes, partial undermining at of building foundation at right corner, and partial undermining of block/mortar slope repair).

Prior remedial cliff work for the Ancient Monastery is also indicated by slope repairs consisting of mortar/concrete and block/mortar. Figure 3.18 depicts the two slope repairs, and indicates partial undermining of the building foundation and block/mortar slope repair. Two drainage pipes discharging over the cliff are also shown.

Along the southern side of the Ancient Monastery, partial undermining of the foundation and the block/mortar slope repair has occurred (Fig. 4.6). It is recommended that the undermined areas be underpinned with block/mortar construction. Care must be taken to ensure adequate bearing conditions for the underpins, for example by carefully excavating bearing notches.

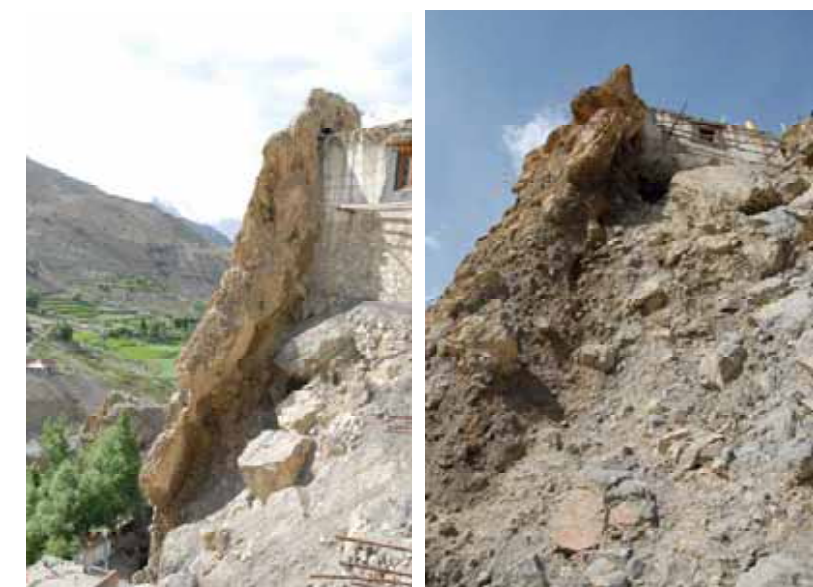
Figure 3.19 Erosion rill and partial undermining of foundation along northern side of Museum (note bimrock fin along eastern side).

Along the northern side of the Museum, an erosion rill has encroached on the structure and partially undermined the foundation (Fig. 3.19). There presently exists only a narrow bimrock fin along the eastern side of the Museum, and continued erosion in this area is judged to have the potential to de-buttress the structure from the eastern side.

As depicted in Figure 4.1, a second area of shotcrete protection is recommended. The shotcrete protection area is approximately 50 m<sup>2</sup> (Fig 4.8), and is intended to mitigate the potential for continued rill erosion and foundation undermining. Specifications for shotcrete placement are consistent with those described in Section 4.1.1. It is further recommended that the undermined foundation area be underpinned with block/mortar construction, or filled with shotcrete.

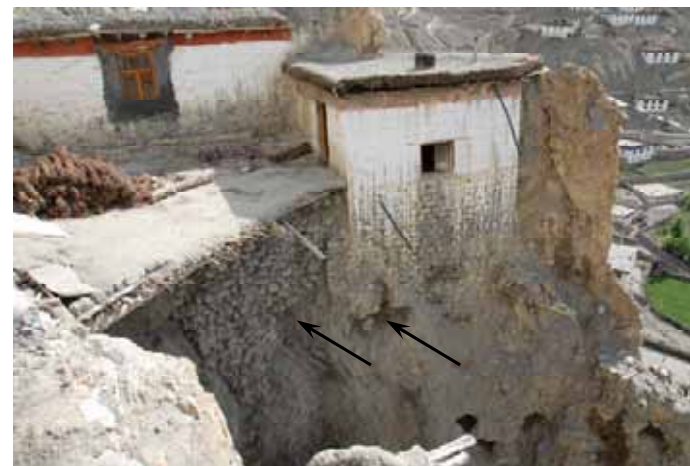
Figure 3.20 Partial undermining of block/mortar slope repair and foundation along southern side of Kitchen (note drain pipes).

Along the southern side of the kitchen, two undermining conditions exist, as shown in Figures 3.20 and 3.21. One instance involves undermining of the block/mortar slope repair (discussed in Section 3.2.1), and the second occurs directly beneath the Kitchen foundation.

Along the southern side of the Kitchen, underpinning of the undermined foundation and block/mortar slope repair is recommended (Fig 4.9). Underpinning can be performed with block/mortar construction, provided that adequate bearing conditions are achieved. Alternatively, as part of the gully surface protection work, underpinning may be performed by filling the undermined areas with shotcrete.

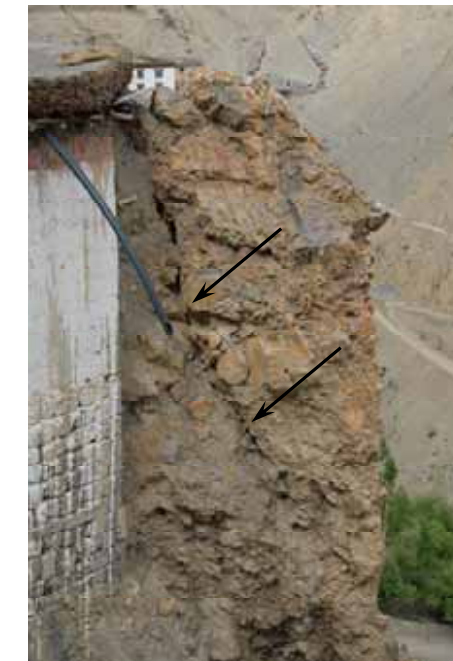
Figure 3.22 Tensile fracturing of bimrock fin along eastern side of Kitchen.

The narrow bimrock fin along the eastern side of the Museum continues along the Kitchen's eastern wall. As shown in Figure 3.22, tensile fracturing of the bimrock has occurred, which can facilitate detachment of a large block. Such detachment would reduce the buttressing effect along the eastern wall.

Figure 4.9 also highlights a bimrock mass that has been isolated from the surrounding rock mass by a tensile fracture. As support of this block is not considered feasible/practical, the hazard of a future rockfall should be anticipated.

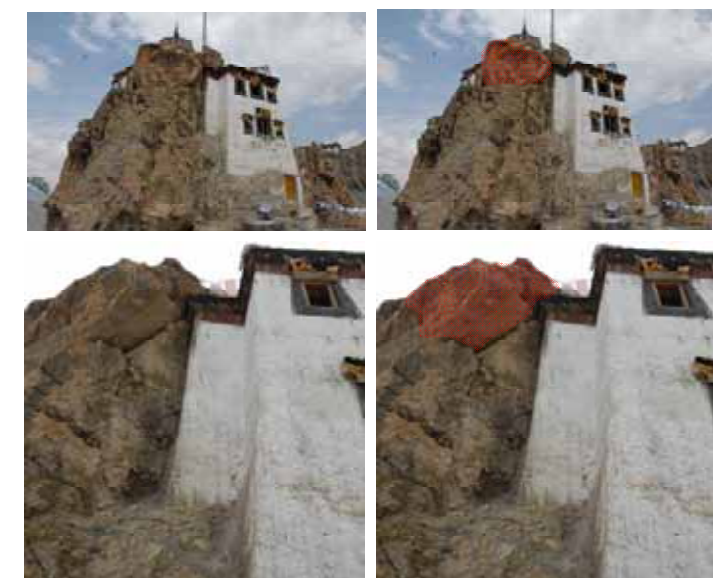
Figure 3.23 Potentially unstable rock block bordering southern side of Tower

Bordering the southern side of the Tower is a large rock block that appears to have been isolated from the surrounding bimrock by two significant fractures. The fractures intersect along a line plunging toward the southeast, creating a removable block (Fig. 3.23). While the block is presently stable, future adverse climatic events, seismic shaking, or simply the passage of sufficient time, may act to destabilize the block and generate a rockfall. Should a rockfall occur, the trajectory would be through the roof of the Ancient Monastery and toward its southern bearing wall.

The large, potentially unstable rock block bordering the southern side of the Tower is considered to pose significant risk, as the failure trajectory would be through the roof of the Ancient Monastery and toward its southern bearing wall (Fig 4.10). For this reason, it is considered prudent to provide supplemental support for the block. Based on restrictive site conditions, a method of support involving anchored straps appears practical. With this approach, two galvanized wire ropes would be strapped across the block, and anchored to the rock mass along the narrow ridgeline between the Tower and Upper Temple. Anchoring can be achieved by providing full strength plate connectors to the ends of the wire rope, then embedding the plates into grouted holes having a nominal depth of about 1.5 m. Anchor placement will be critical for ensuring adequate performance of the supplemental support, and the wire ropes should be lightly pre-tensioned to provide a small amount of active support.

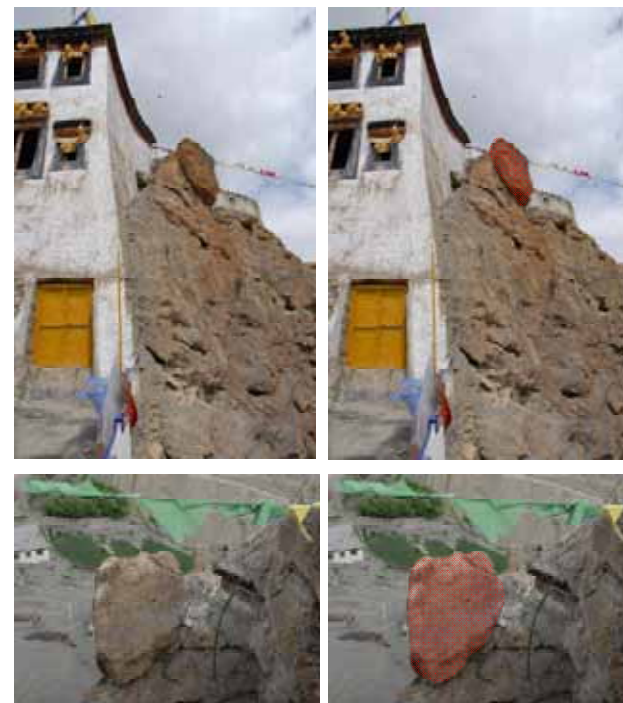
Figure 3.24 Potentially unstable rock block adjacent to northern side of Tower.

A potentially unstable rock block also exists along the northern side of the Tower (Fig 3.24). The block appears to be almost completely isolated by the steeply dipping underlying fracture. The stability characteristics are unfavorable, and moderate disturbance may potentially result in block detachment. In the case that a rockfall develops, the trajectory would not be toward the Ancient Monastery Complex, rather toward the new parking garage construction and village below.

A potentially unstable rock block also exists along the northern side of the Tower (Fig 4.11). In the case that a rockfall develops, the trajectory would be toward the new parking garage construction and village below. It is not considered feasible/practical to support this block. An option for reducing the risk of a future rockfall involves the controlled removal (scaling) of the block. Absent such measures, the hazard of a future rockfall should be anticipated.

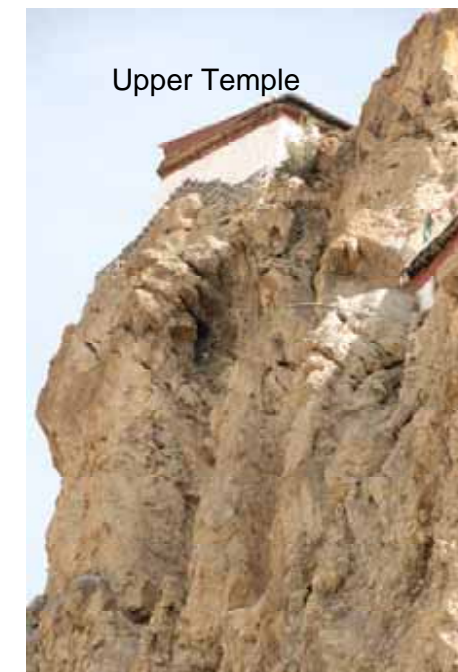
Figure 3.26 Condition of bimrock cliff along southern side of Upper Temple

The bimrock cliff bordering the southern side of the Upper Temple is near vertical, with a height of about 65 m (Fig 3.25). As depicted in Figure 3.26, the bimrock locally appears fractured and loosened.

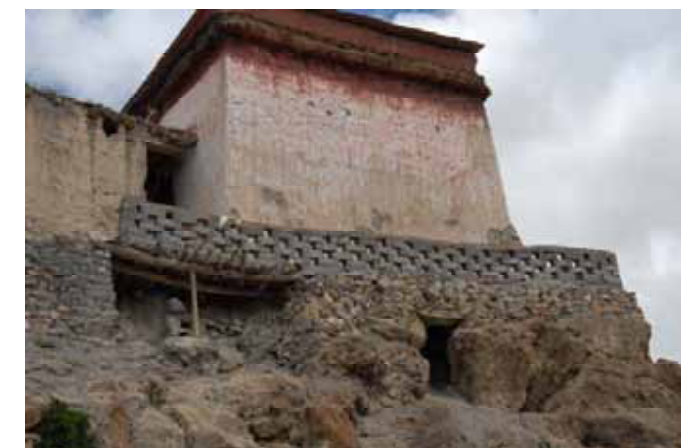
Figure 3.27 Foundation undermining along western side of Upper Temple (note wood post and beams).

Partial undermining of the Upper Temple foundations and access walkways has occurred along the western and eastern sides of the structure. As shown in Figure 3.27, spanning across the undermined areas has been accomplished with timber and steel posts and beams.

It is recommended that undermined foundation elements along the western and eastern sides of the Upper Temple (Fig. 4.12 and 4.13) be underpinned with block/mortar construction. Care must be taken to ensure adequate bearing conditions for the underpins, for example by carefully excavating bearing notches. Additionally, re-routing of the water discharge to low vulnerability areas, or

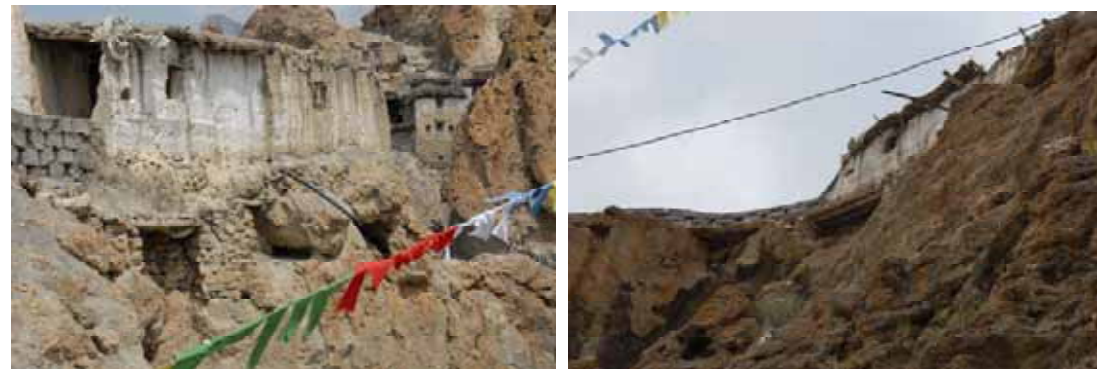
Figure 3.28 Foundation undermining along eastern side of Upper Temple (note block and mortar underpinning, spanning timber beams, and drainage pipe).

Foundation undermining along the eastern side is similar in its nature, and has been addressed with remedial block and mortar underpinning and spanning timber beams. Figure 3.28 depicts the undermining along the eastern side of the Upper Temple, together with a drainage pipe discharging directly onto the cliff face in the undermined area.

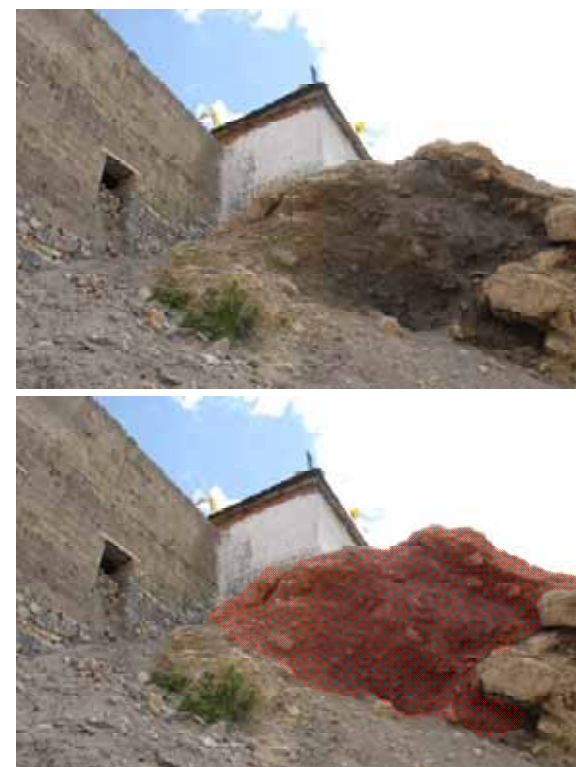
Figure 3.29 Castle of the Nono, depicting overhanging bimrock outcrop along eastern side of structure.

Along the eastern side of the Castle of the Nono is an overhanging bimrock outcrop having a height of about 3-4 m (Fig 3.29). The overhang is considered a transient feature, with a high susceptibility to long term slope instability. The configuration of the overhang is such that a slope failure, extending from the toe to at a vertical angle (or steeply dipping in the reverse sense of the overhang) could undermine a portion of the foundation (the corner of the white building shown in Figure 3.29).

The overhanging bimrock outcrop along the eastern side of the Castle of the Nono has a high susceptibility to long term slope instability (Fig 4.14). To mitigate to potential for resulting foundation undermining, it is recommended that the slope overhang be supported according to the shoring concept depicted in Figure 4.15. The shoring scheme consists of timber wall plates, rakers, and struts, each envisioned on approximately 1.5 m centers. To achieve adequate bearing, the rakers should be embedded in shallow concrete-filled foundation holes.

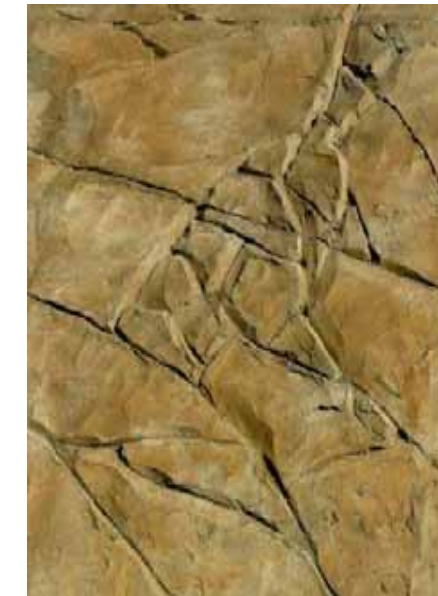
Figure 4.3 Example of textured and pigmented shotcrete wall.

The aesthetic properties of traditional shotcrete can be a drawback for cultural heritage restoration work. However, as shown in Figure 4.3, natural pigment additives and a textured finish can result in an attractive, natural looking surface.

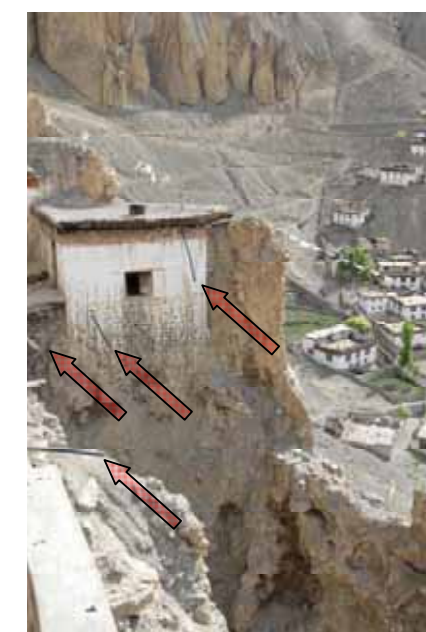
Figure 4.4 Prevent water discharge into gully along eastern side of Ancient Monastery.

Diversion and control of surface runoff, so as to minimize discharge into the large gully, is also recommended. This will require re-grading of surfaces to prevent sheet flow onto the cliff face and re-routing of drainage pipes to low vulnerability areas (such as the more gentle slopes to the north of the Ancient Monastery). Alternatively, runoff can be collected and conveyed in a secured drop pipe (e.g. corrugated HDPE), to a location beyond the toe of the bimrock cliffs. Figure 4.4 depicts four drainage pipes requiring re-routing.

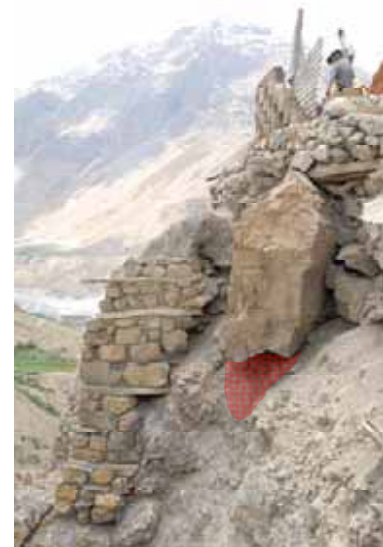
Figure 4.5 Underpin large block along eastern side of Ancient Monastery.

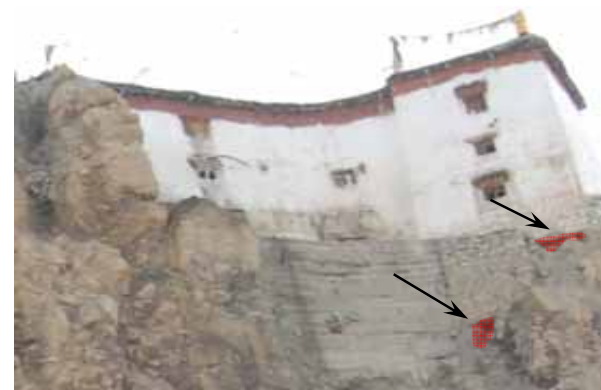
Figure 4.6 Underpin foundation elements along southern side of Ancient Monastery.

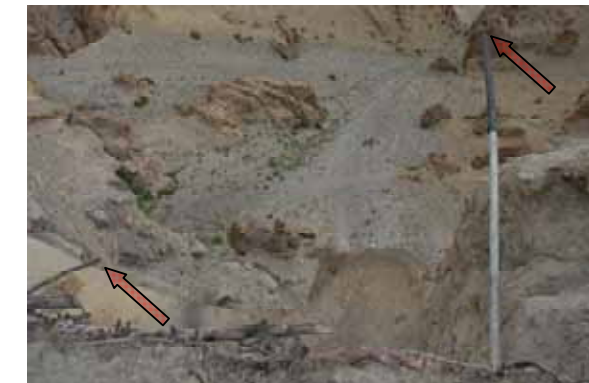
As shown in Figure 4.7, drainage pipes convey water from the monastery and discharge directly onto the cliff face. Re-routing of the discharge to low vulnerability

Figure 4.7 Prevent water discharge over southern supporting cliff of Ancient Monastery.

conveying it in a secured drop pipe (e.g. corrugated HDPE), to a location beyond the toe of the bimrock cliffs, is recommended.

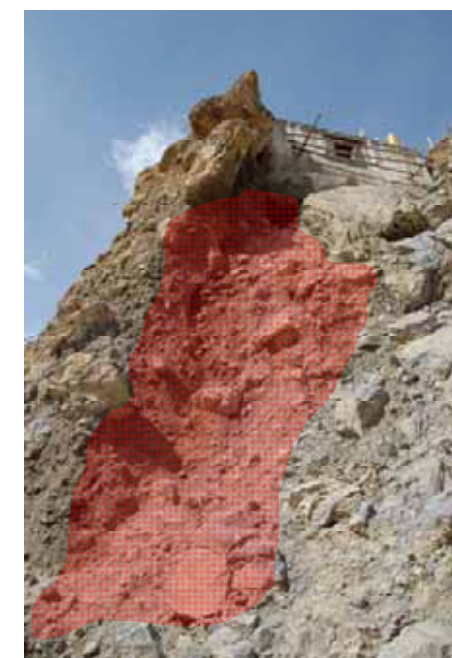
Figure 4.8 Shotcrete protection and underpinning along northern side of Museum.

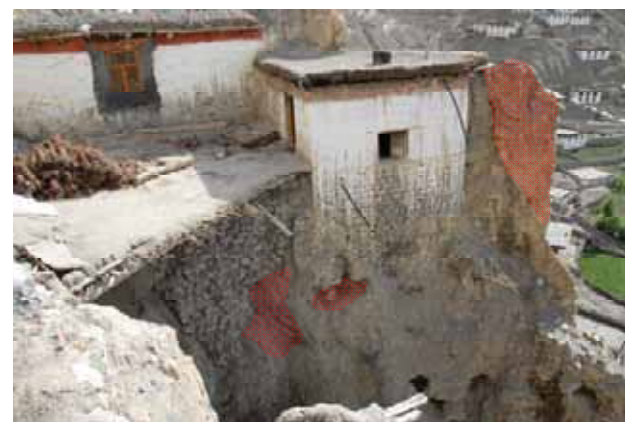
Figure 4.9 Underpin foundation elements along southern side of Kitchen.

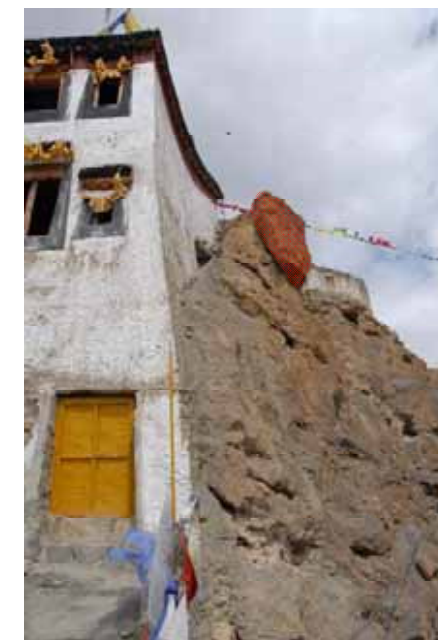
Figure 4.11 Potentially unstable block along northern side of Tower.

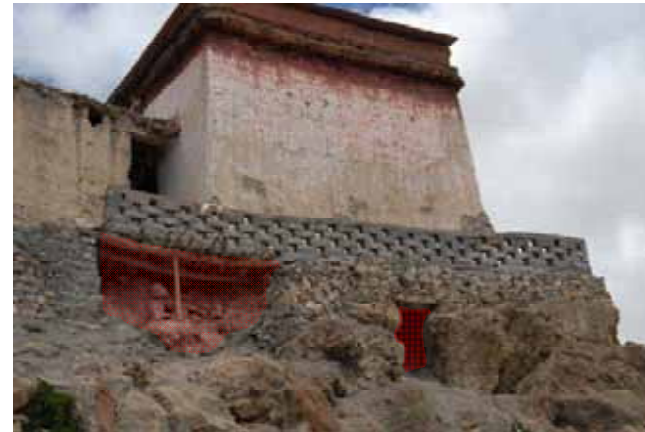
Figure 4.12 Underpin foundation elements along western side of Upper Temple.

conveying it in a secured drop pipe (e.g. corrugated HDPE), to a location beyond the toe of the bimrock cliffs, is recommended.

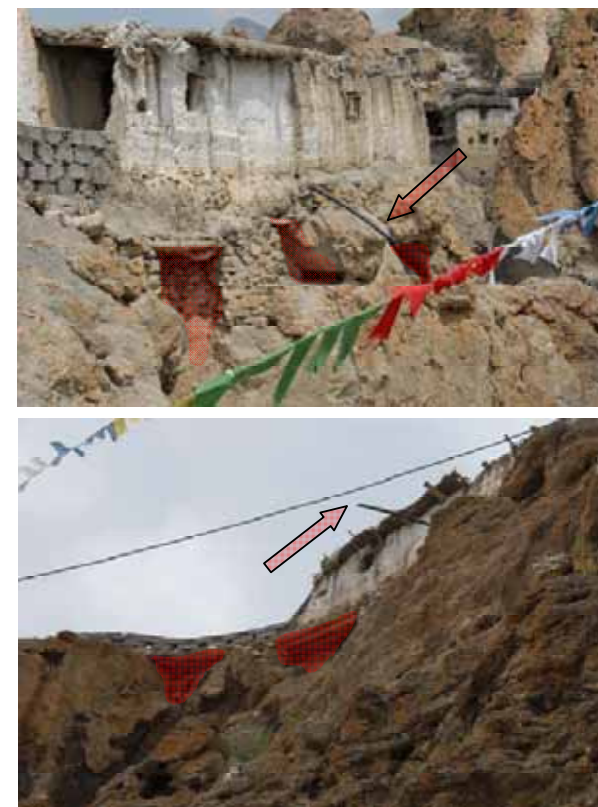
Figure 4.13 Underpin foundation elements along eastern side of Upper Temple, and prevent water discharge over cliff.

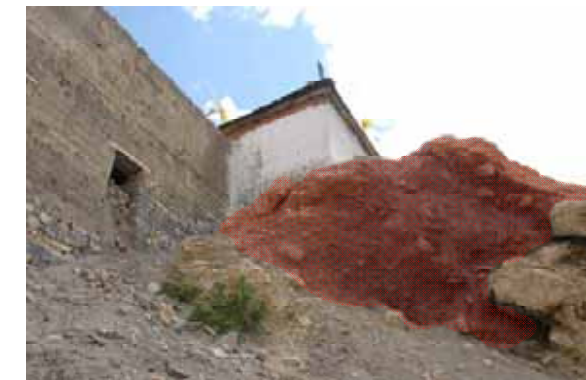
Figure 4.14 Overhanging slope at Castle of the Nono.
